MARYLAND HISTORICAL TRUST DETERMINATION OF ELIGIBILITY FORM

Property Name: Bridge H-16		Inventory Number:	HA-1875
Address: Aldino - Stepney Rd Bridge	City: Aberdeen	Zip Code	: 21001
County: Harford County	USGS Topographic Ma	p: Aberdeen, Maryland, 1	985
Owner: Maryland State Highway Administrati	on	Is the property being evalua	ated a district? NO
Tax Parcel Number: Tax Map Number	er: Tax Account ID	Number:	
Project: Adams Property			
Site visit by MHT Staff: x no y			
Is the property located within a historic district?			
If the property is within a district	District 1	nventory Number:	
NR-listed districtyes Eligible distric			
Preparer's Recommendation: Contributing r			
If the property is not within a district (or the property Preparer's Recommendation: Eligible Criteria: A B C D Documentation on the property/district is presented.	yesxno Considerations:A		
	Eligibility Review F	orm dated April 11, 1997.	
Description of Property and Eligibility Determine The property was most rece Its condition was unchanged s Property/District Maryland Hi the library of the Maryland H The property is described in District Maryland Historical by Kimberly Prothro Williams, 11, 1997. Following is

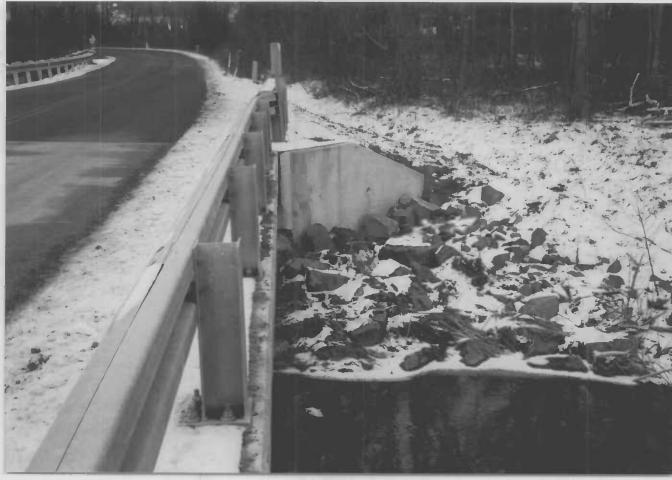
HA-1875 BR1048 1-16 ALDINO-STEPLEY RID BRIDGE ABERDEEN, HAREDRY CO. MD 21001 PHOTO BY: WMISON STAAR 01 17 03 NEGEMB SUPO BUDGE ASUTMENT STEED OF THE SECOND ALDINO-STEPNEY RD. BRIDGE HA-1875 ABERDEEN, MD 2100 01.03

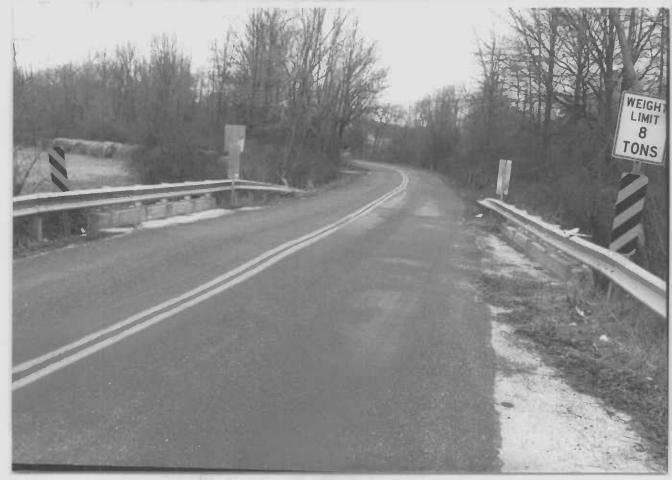
1/4

HA-1875 HARFORD COUNTY MD VOHN TARQUINIO 24 JAN 1995 - HARYEAND SHOO SMA - STATE HIGHWAY BRIDGE HILD OVER CARSINS RUN - VIEW LOOKING NORTH ON ALDINO STEPNEY ROAD

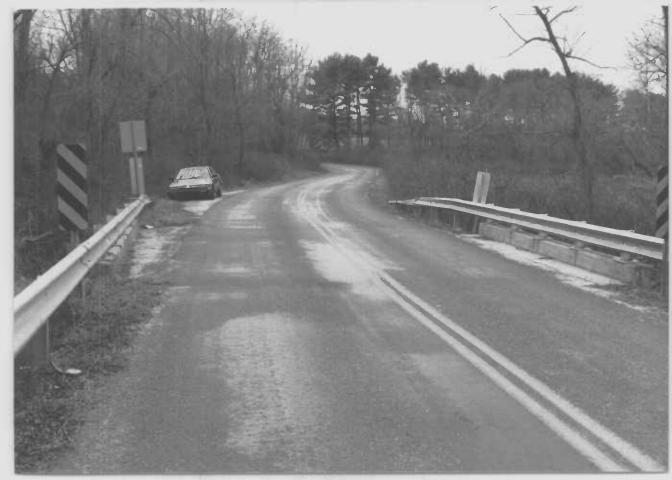
2/4

HARFORD COUNTY, MD JOHN TARQUINIO 24 JAN 1995 - HARYLAND SHPO SHA

- STATE HIGHWAY BRIDGE HIG OVER CARSONS RUN

- VIEW LOOKING SOUTH ON ALDINO STEPNEY ROAD

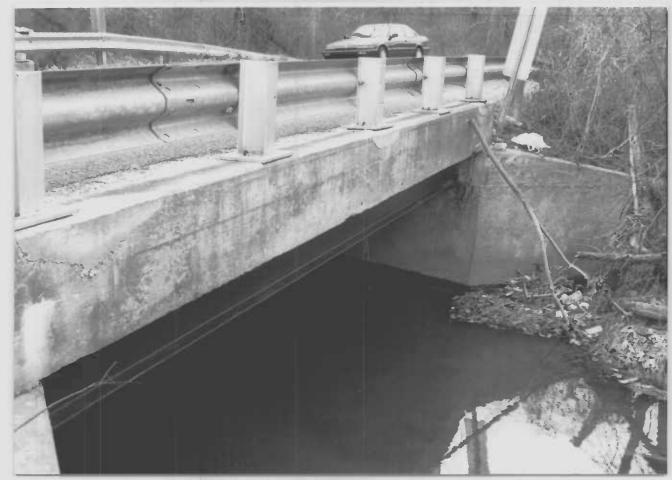
HA- 1875 HARFORD BOUNTY, MD JOHN TARQUINIO 29 JAN 1995 MARYLAND SHOO SHA - STATE HIGHWAY BRIDGE HIL OVER CARSINS RUN - VIEW LOOKING EAST 3/4

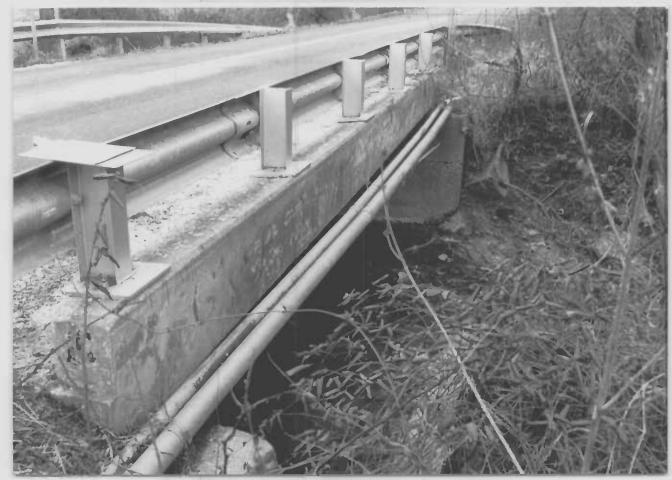
4/4

HARFORD COUNTY, MD JOHN TARQUINIO 24 JAN 1995 MARYLAND SHPD SHA

- STATE HIGHWAY BRIDGE HILD ONER CARSINS RUN

- VIEW LOOKING WEST
